Flood Investigation Report

Various Locations, Solihull 27th May 2018

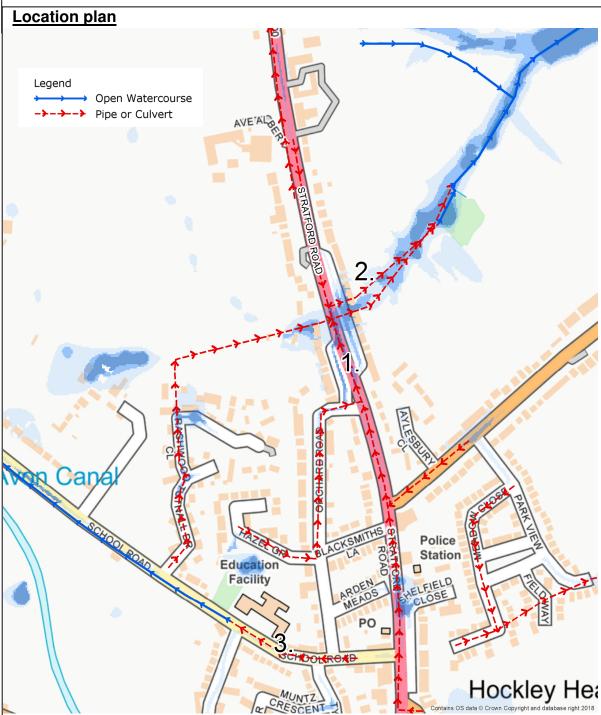
Mapping produced by the Environment Agency showing existing areas of risk of flooding from rivers and watercourses and also from surface water in Hockley Heath. The mapping is based on computer models to assess long term risk and does not take into account factors such as blocked drains or burst pipes.

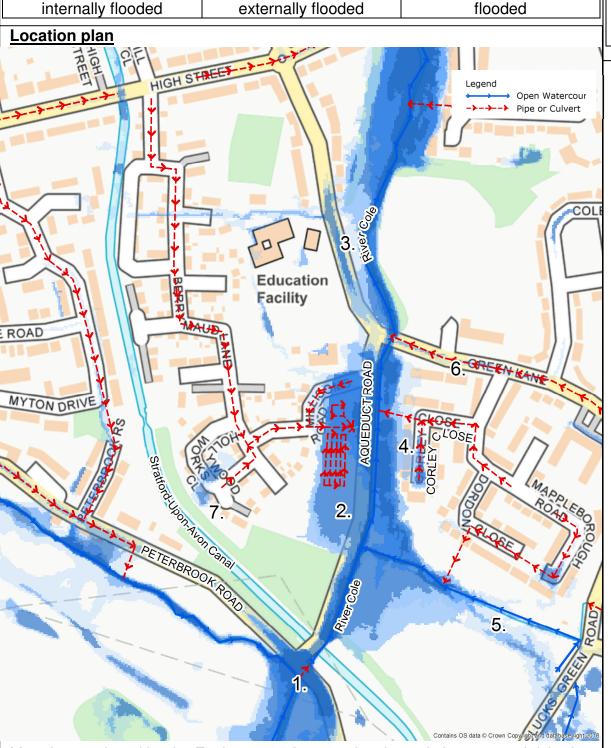
Mapping produced by the Environment Agency showing existing areas of risk of flooding from rivers and watercourses and also from surface water. The mapping is based on computer models to assess long term risk and does not take into account factors such as blocked drains or burst pipes.

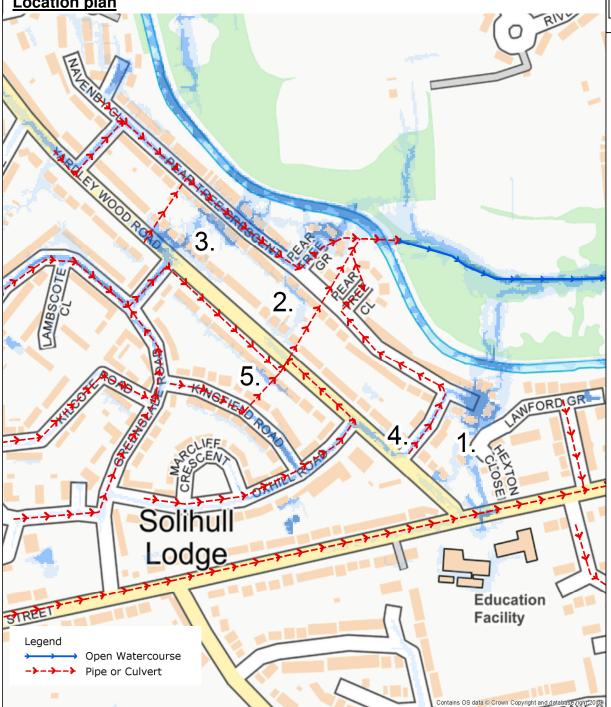
ocation	plan
-

Mapping produced by the Environment Agency showing existing areas of risk of flooding from rivers and watercourses and also from surface water. The mapping is based on computer models to assess long term risk and does not take into account factors such as blocked drains or burst pipes.

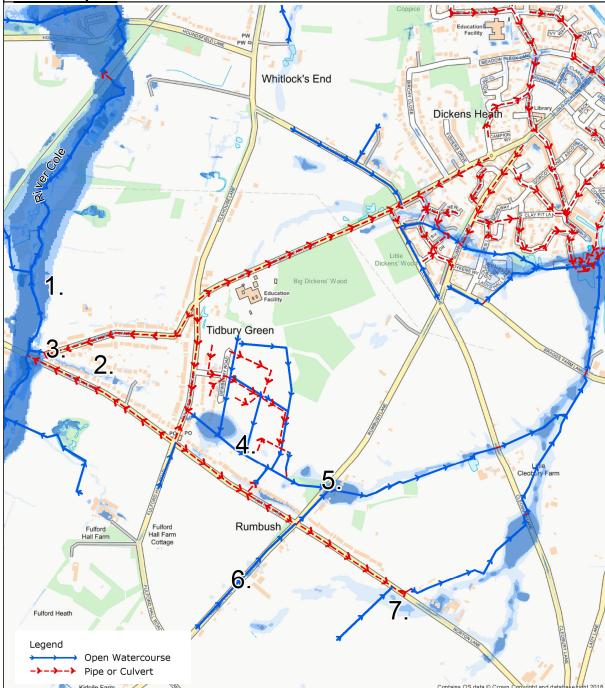
Location plan

Mapping produced by the Environment Agency showing existing areas of risk of flooding from rivers and watercourses and also from surface water. The mapping is based on computer models to assess long term risk and does not take into account factors such as blocked drains or burst pipes.
